The Performance of Low-Rise Open Span Heavy Steel Structures In Extreme Winds

Joe R. Charlton, B.S., P.E.

A REPORT

CIVIL ENGINEERING

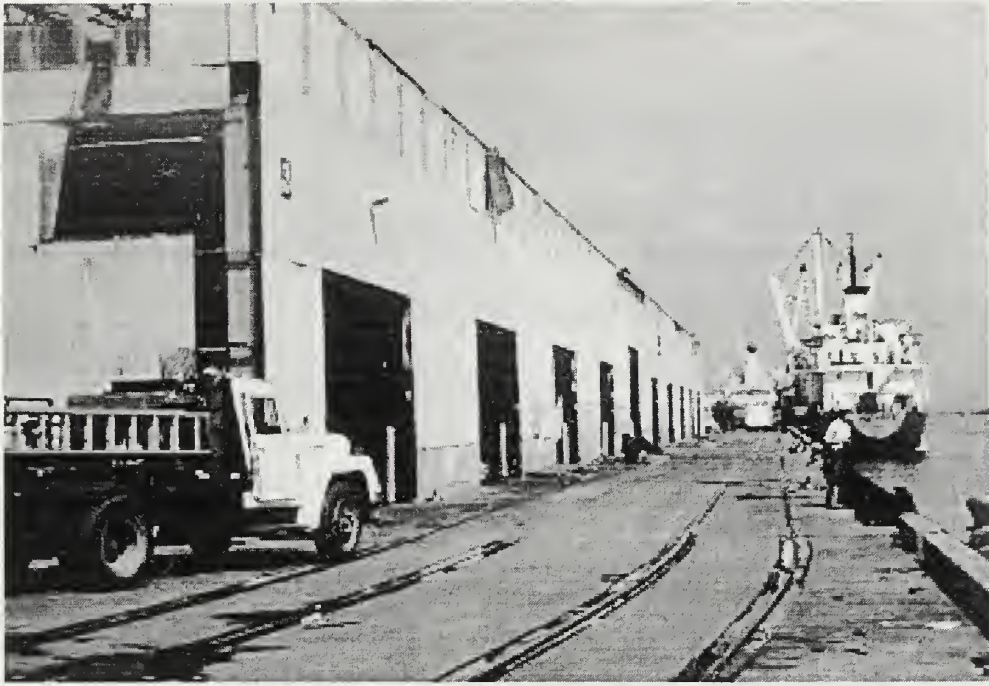
Figure 4.1 South Exterior Elevation of Building 3

This warehouse building sustained no significant structural damage, as can be seen in Figures 4.1, 4.2, and 4.3. The only damage noted was the failure of several large overhead doors and the removal of some of the corrugated metal roof and wall panels.

The probable cause of the roof and wall panel failure was the prior failure of the large overhead doors located on the side of the building running parallel to the railroad tracks, as seen in Figure 4.1. These overhead doors failed due to positive pressure

generated by wind blowing normal to the surface of the doors. Once the two overhead doors failed, the internal pressure inside the building increased and the roof panels and siding were torn from the structure due to the combined internal and external pressure.

There are several important points to note in the damage done to this structure. First, there was little or no damage done to the steel framing and girts supporting the overhead doors. This indicates that either the door curtain had insufficient structural capacity to transfer the wind load to the frame, or that the door tracks deflected enough to allow the curtain guides to separate from the tracks. Regardless of the mechanism, the failure of these and other overhead doors has been observed repeatedly in other structures that sustained damage.

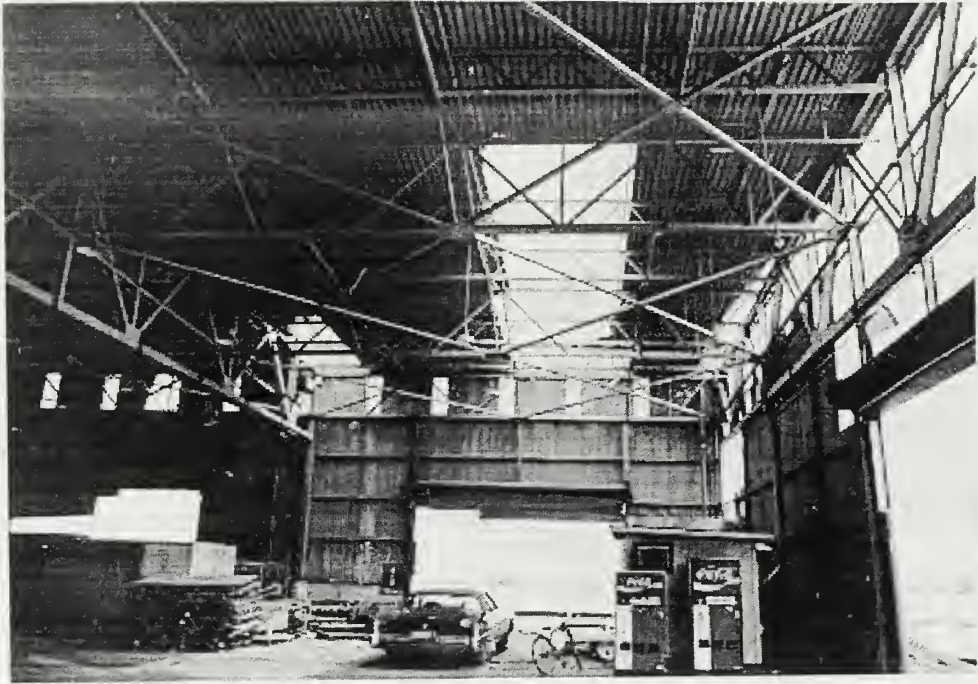
Figure 4.3 Interior Elevation of Building 3

The second point to notice is the lack of damage to any of the wall girts or roof joists that supported the damaged panels. The lack of damage to the girts and joists can be attributed to a combination of the small vertical spacing of the girts, approximately three feet, the use of heavy “C” channel sections, and the premature failure of the corrugated siding. It is important to note that since the siding failed, the girts were probably not subjected to the maximum wind loads.

The last item to notice is the mode of failure of the corrugated panels. Since the screws remained in the girts after failure, this indicates that either the fastener spacing was too large, the heads of the fasteners were too small, or the thickness of the corrugated siding was insufficient to prevent the corrugated siding from experiencing localized failure around the screws.

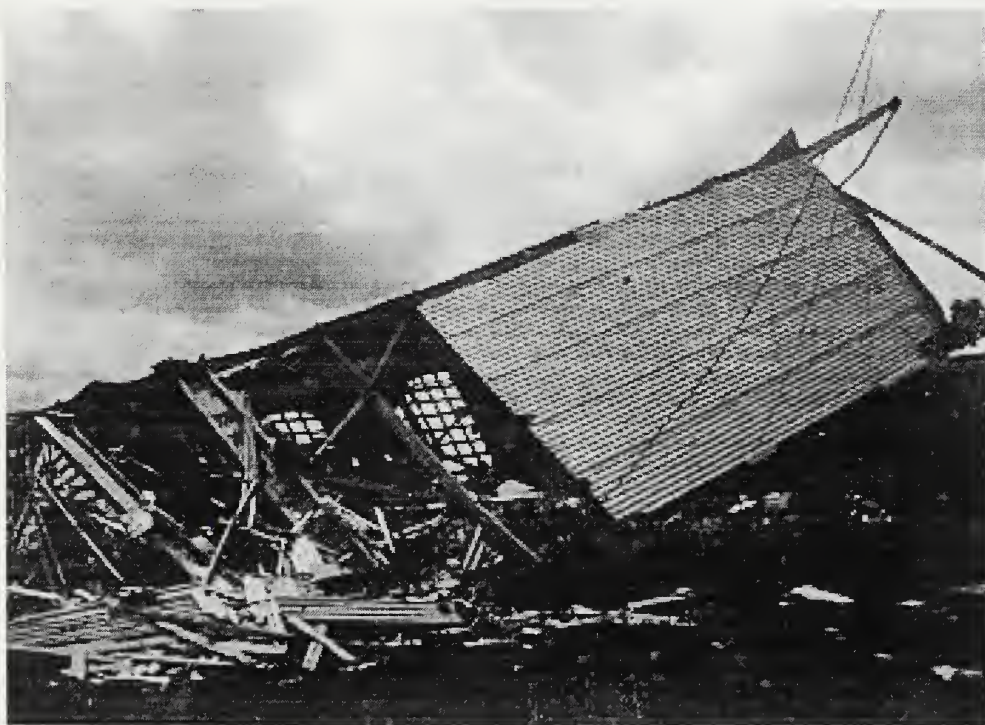
Figure 4.8 Failure of Parachute Tower

As seen in Figure 4.8, the parachute drying tower was totally destroyed by the Altus tornado. The failure of the tower was caused by excessive wind loads on the windward and leeward walls. These wind loads were sufficient to cause the anchor bolts on the southeast and northeast columns to fail in tension. Once the anchor bolts failed, the overturning moment generated by the easterly wind caused the building to rotate about the other two columns and collapse. A close up of the anchor bolt failure can be seen in Figure 4.9 and a close up of the column base plate in Figure 4.10. Figure 4.10 shows definitively that the base plate did not fail.

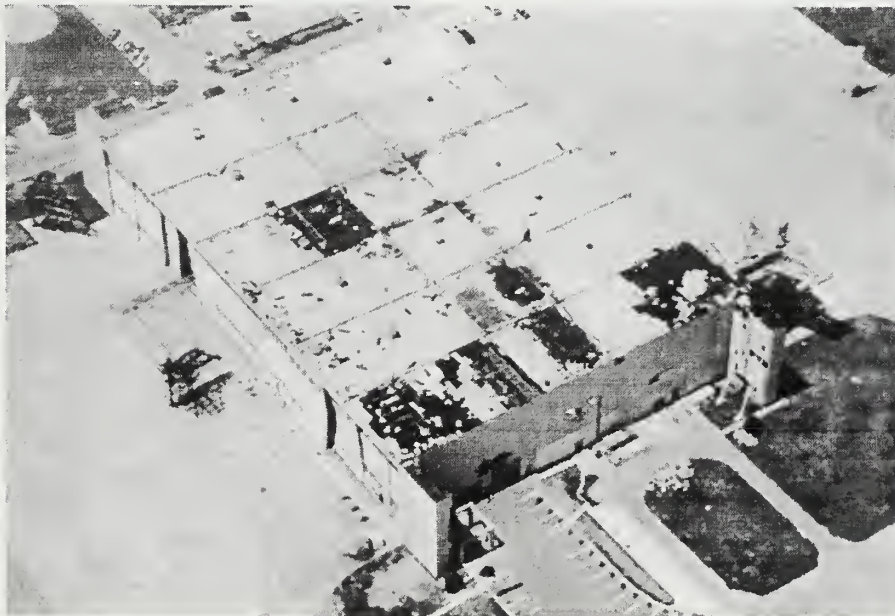
Figure 4.12 Aerial View of Damage to Building 285

Overall, the hangar performed well when subjected to these severe winds. The exterior corrugated asbestos siding performed well and experienced only localized failure. There were no failures noted in the heavy “C” channel wall girts or the roof trusses supporting the corrugated siding and the roof decking, respectively. No failures were noted on the main structural elements. The only damage to this building was the removal of a portion of the roofing material and the roof decking, structural damage to two rail mounted hangar door sections, and the removal of exterior corrugated siding along the door pockets. The damage to the hangar is shown in Figures 4.12 through 4.17.

The majority of the damage to the roof covering seen in Figure 4.12 is along the edges of the roof line. This damage is consistent with the higher suction pressures that are typically experienced at the leading edges of a structure with a flat roof. One other factor that may have precipitated the damage to the roof membrane is the partial failure of

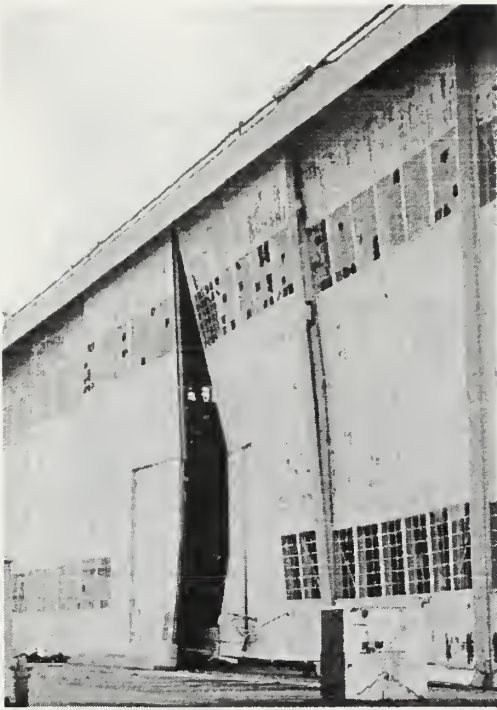
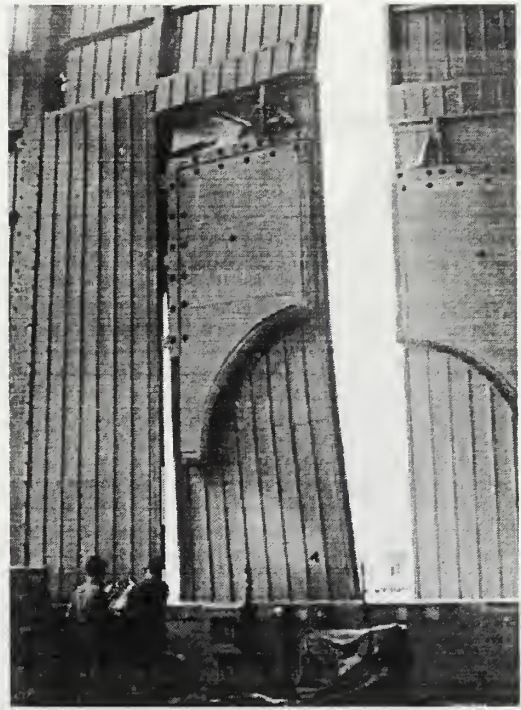
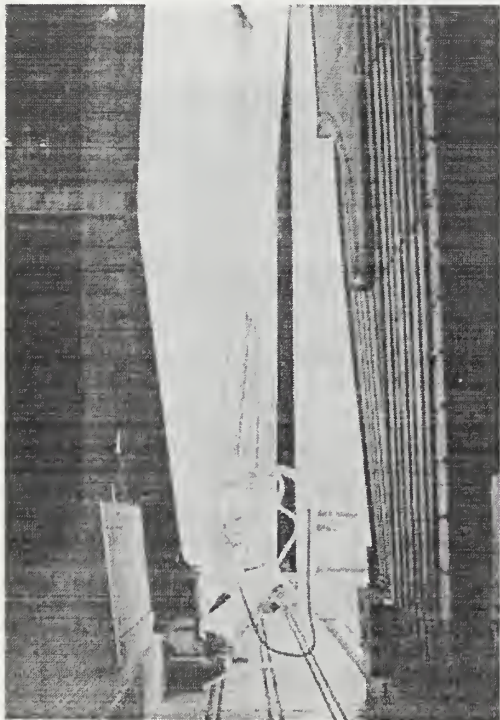
The partial failure of two sections of the hangar door, as seen in Figures 4.13, 4.14, and 4.15 was caused by wind acting normal to the door surface and weakness in the free edges of the door sections. Because of the secondary openings in the door sections, they did not have a continuous member along their free edge. This lack of a continuous member weakened the structural framing and the lighter secondary framing was unable to transfer the loads into the upper header and the lower rail seen in Figure 4.15. This failure was most likely not due to either a design or a construction deficiency but was simply an area of the structure that had little redundancy.

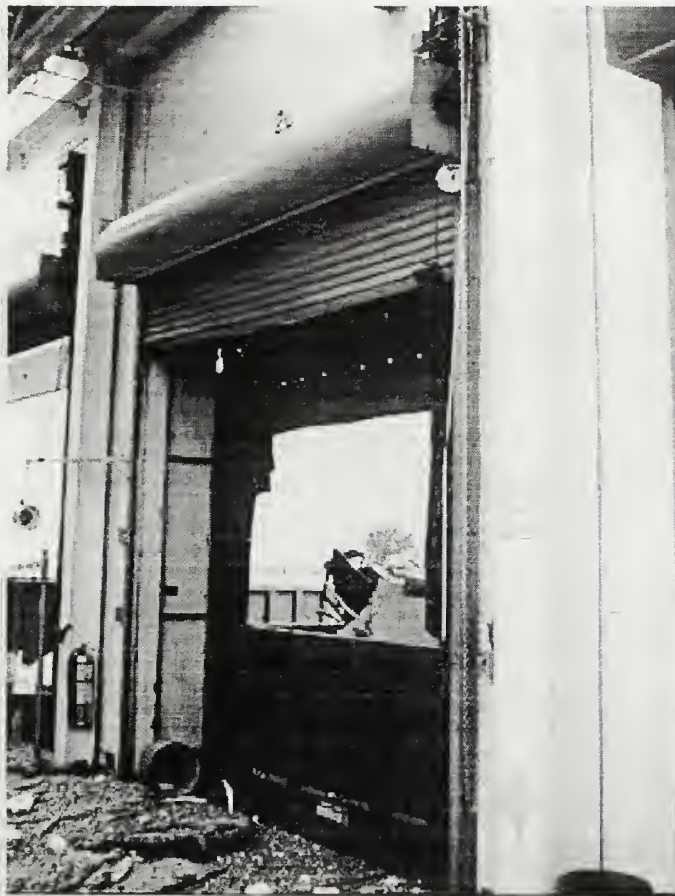
Figure 4.19 Undamaged Overhead Door

The main structural system performed well and sustained very little damage as did the large overhead doors, shown in Figure 4.19. The only damage to the main structural system was a horizontal crack in the CMU shear wall. The other element damaged was the corrugated steel roof decking. Approximately 80% of the corrugated steel roof deck was torn from the building. The damage mentioned can be seen in 4.20 and 4.21.

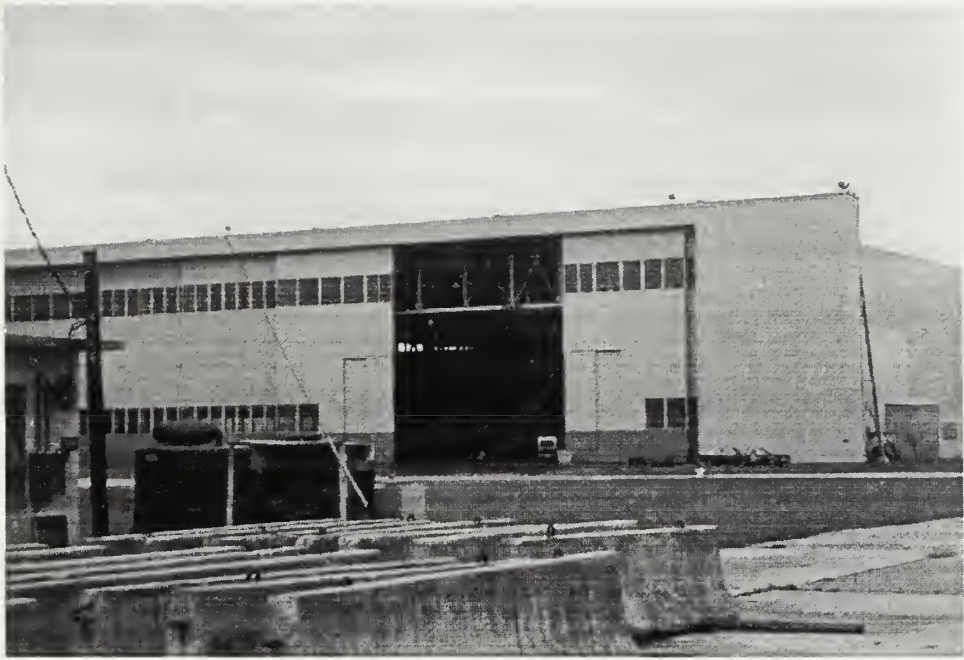
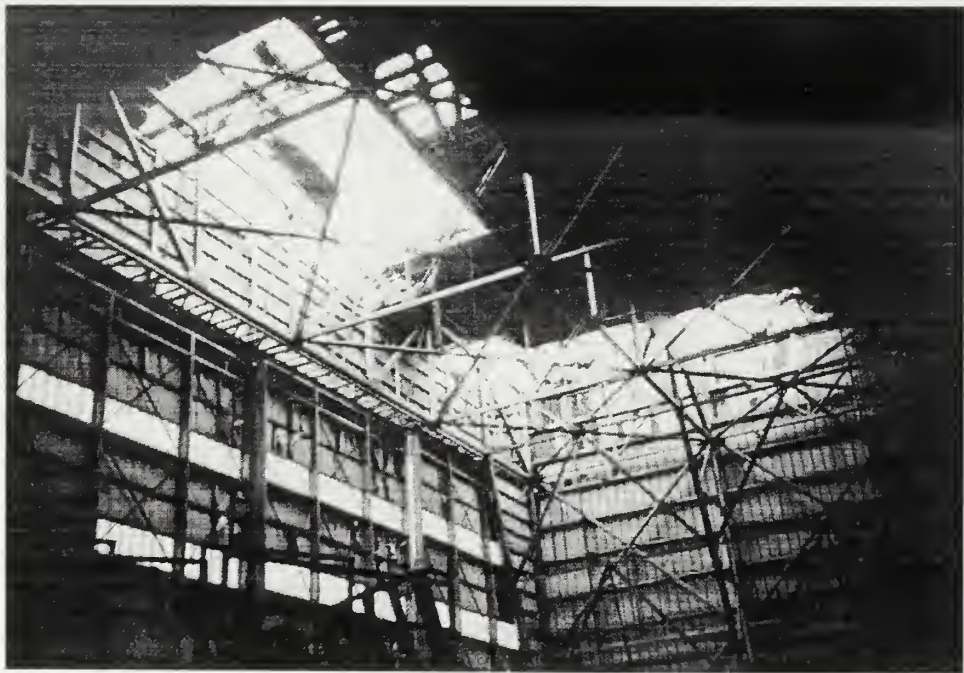
The only visible damage to this hangar is damage to the roof covering and decking. All of the structural members performed as designed, as did the corrugated metal siding. All of the windows in the structure remained intact, as did the hangar doors. These observations of the extent of the damage generally agree with the assessment by McDonald and Smith, 1990. The extent of the damage can be seen in Figures 4.22 and 4.23.

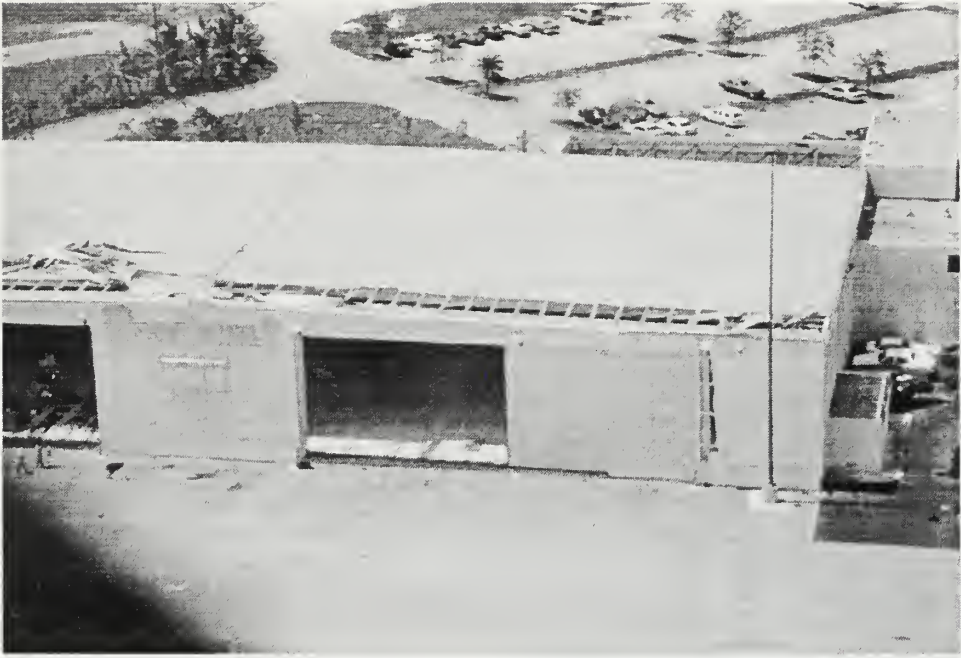
Figure 4.25 Elevation of Beechcraft Hangar

The main component that was damaged on all three hangars was the roof decking. The corrugated siding on the front of the Beechcraft hangar also received minor damage at the door pocket, see Figure 4.25.
